# Encapsulant dependence of Ag-ion migration phenomenon during damp heat test with voltage bias

<sup>1</sup>Masaaki Odoi, Hirofumi Zenkoh

<sup>1</sup>Mitsui Chemicals Tohcello, Inc.

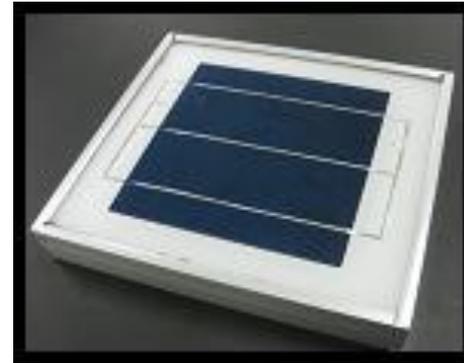
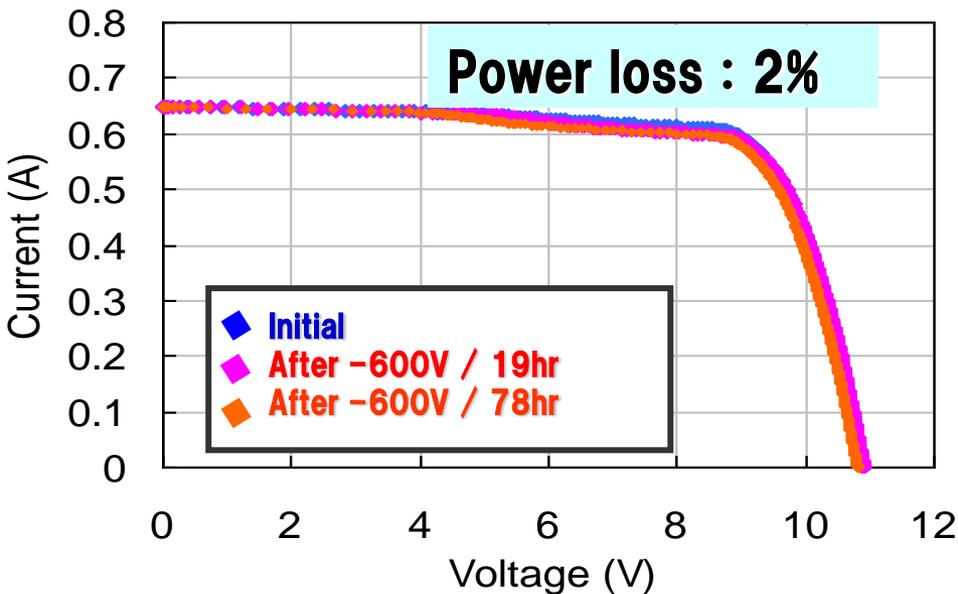
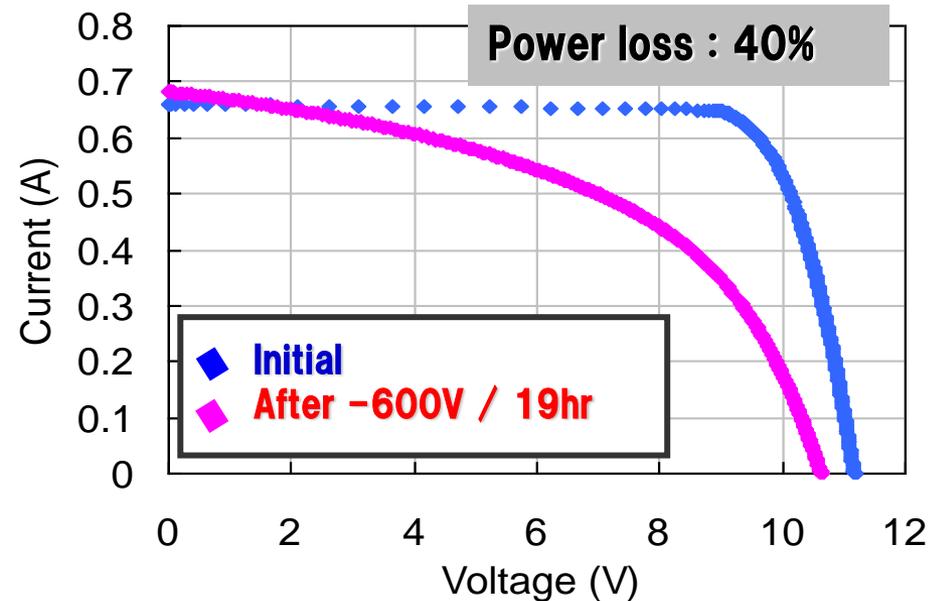
- **85°C85% -1000V**
- Cell: 6inch multi-crystalline
- Module : 1 cell

- Irradiance : 1000W/m<sup>2</sup>

**PID prone cell has been selected with EVA-1 encapsulant**

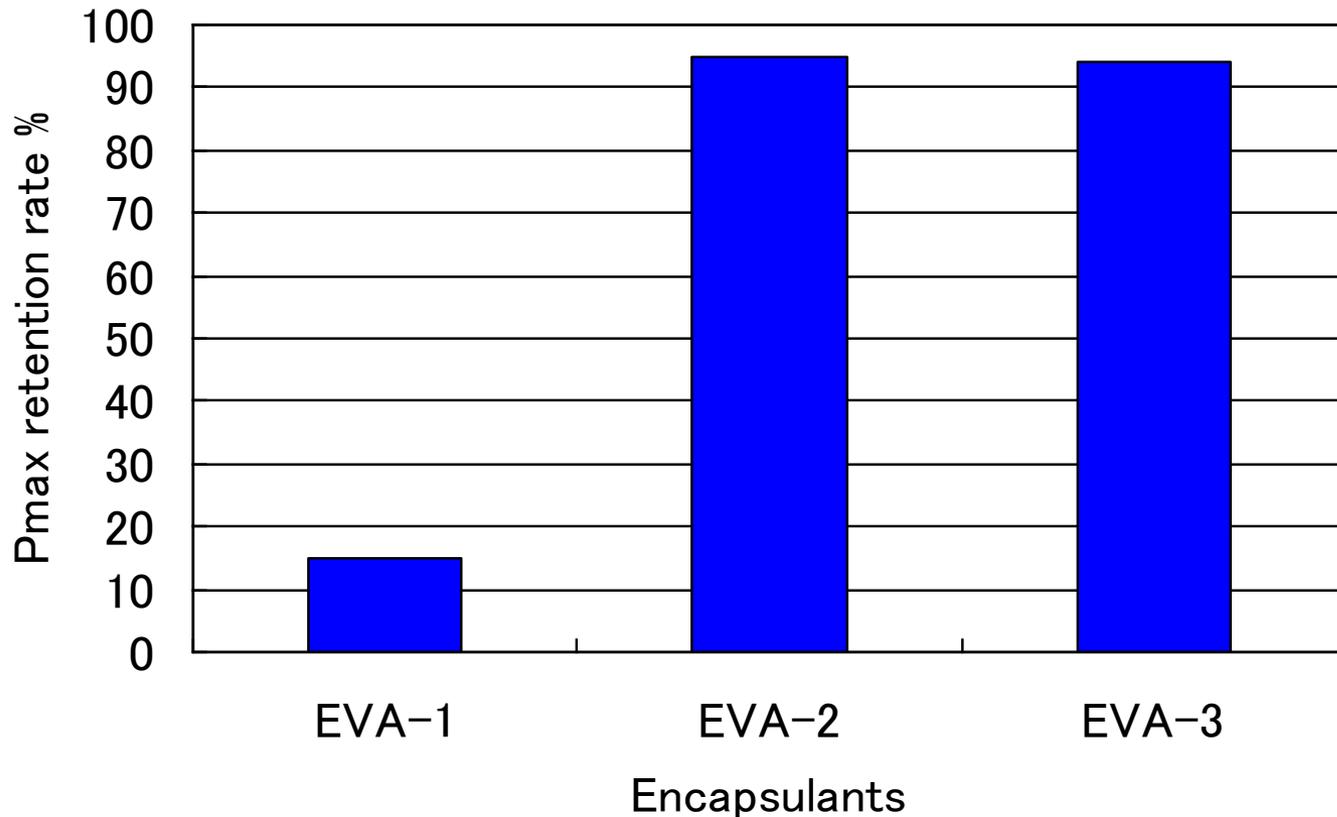
6inch 1cell mini module  
85°C/85%RH, -1kV, 24hr

**EVA-2 and EVA-3 shows better PID durability than EVA-1**

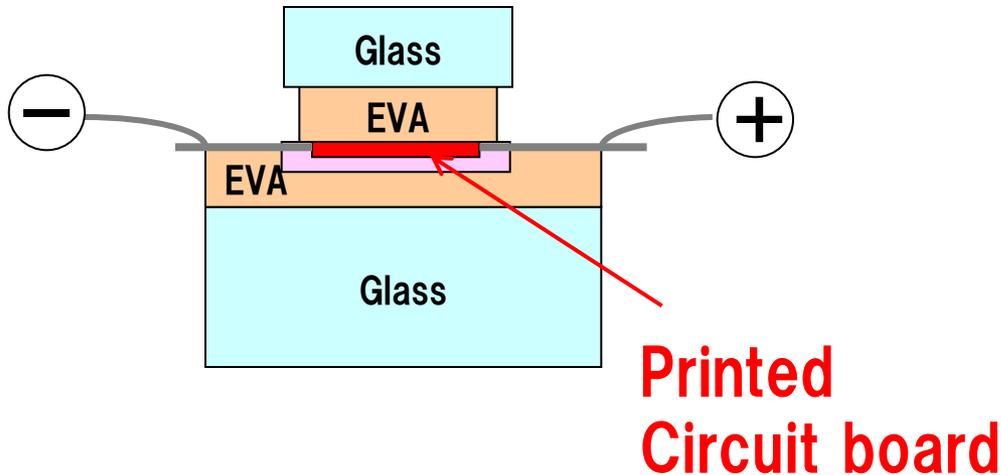
## Sample structure

Electrode : Ag printed circuit board

Line/Space : 100um/100um

Bias: DC100V

Conditions: 85°C/85%RH

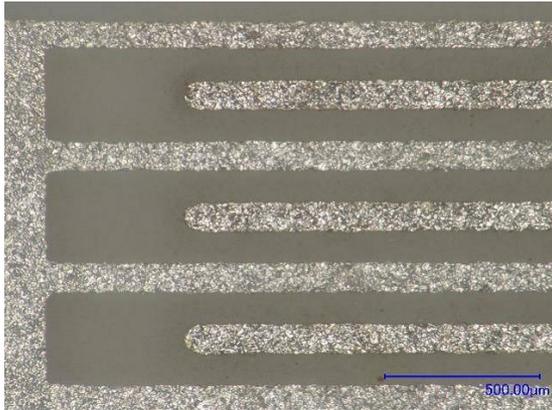
## EVA-1

**EVA-2** shows silver dendrite formation between electrodes

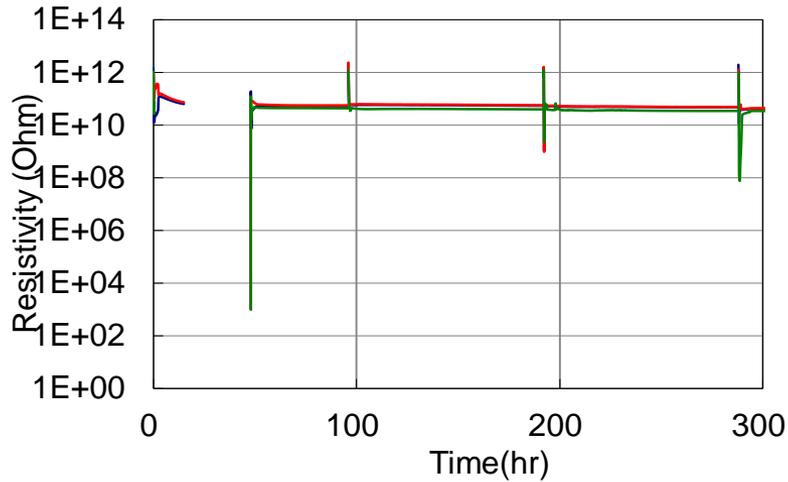
## EVA-1

**EVA-2** shows resistivity break down caused by silver dendrite

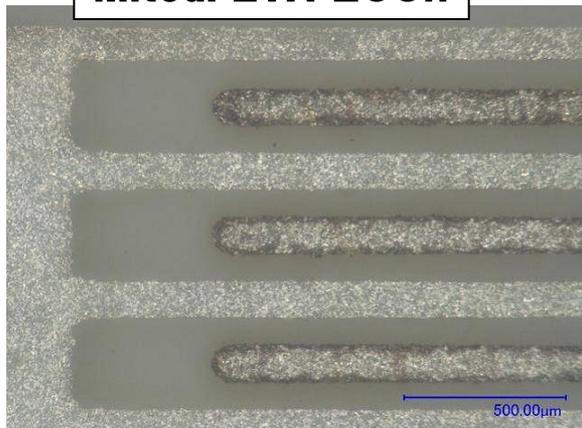
**Mitsui EVA 288h**

kept initial resistivity

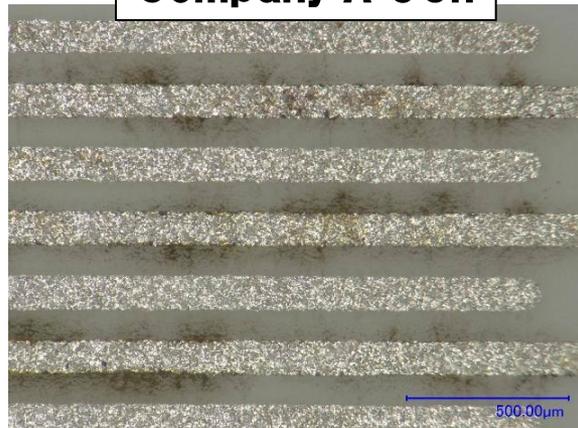
**Company A 96h**

Short-circuited within 100hrs

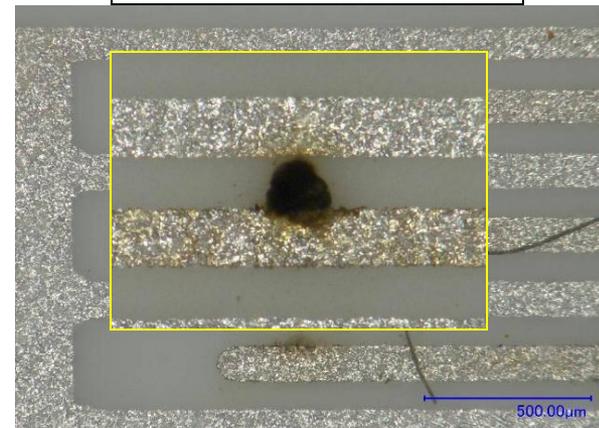
**Company B 192h**

Short-circuited within 300hrs

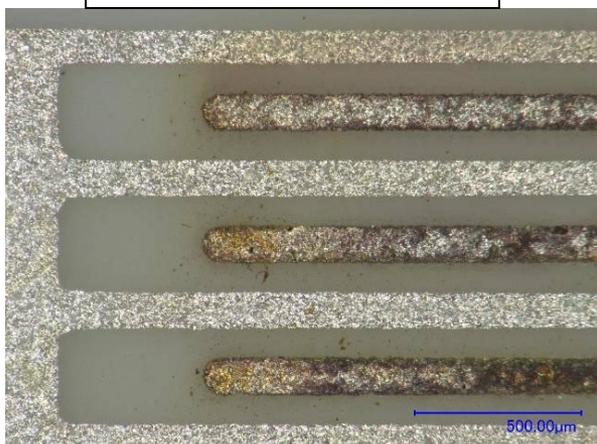
**Company C 288h**

kept initial resistivity

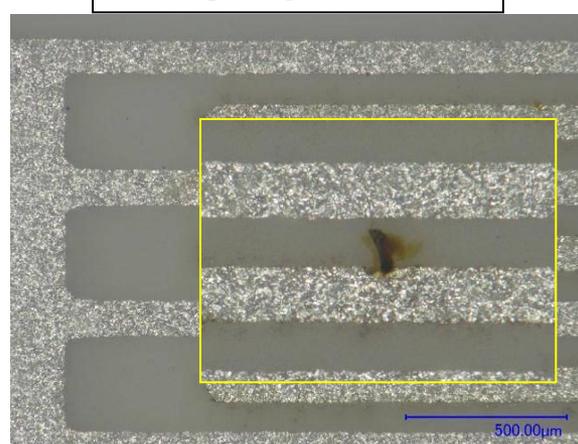
**Company D 288h**

Short-circuited within 100hrs

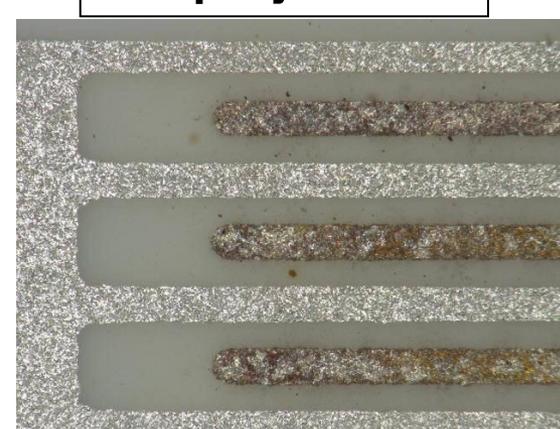
**Company E 288h**

kept initial resistivity

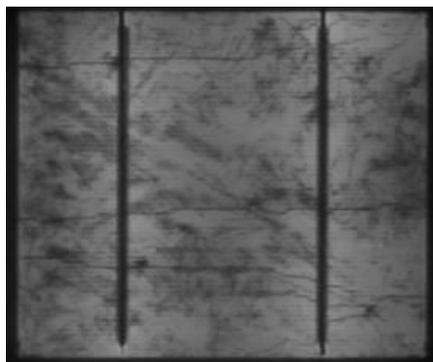
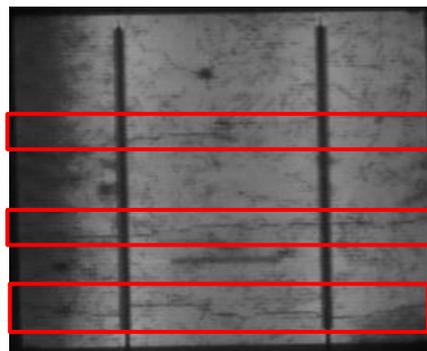
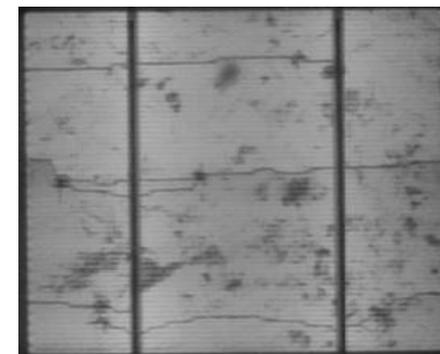
EL  
image  
s

Snail Tracks are observed on the **EVA-2** module
