Sequential and Weathering Module Testing and Comparison to Fielded Modules

NREL PV Module Reliability Workshop 2015

W. Gambogi¹, J. Kopchick¹, T. Felder¹, S. MacMaster¹, A. Bradley¹, B. Hamzavytehrany¹, C.-F. Wang², H. Hu², Y. Heta³, Lucie Garreau-Iles⁴ and T. J. Trout¹

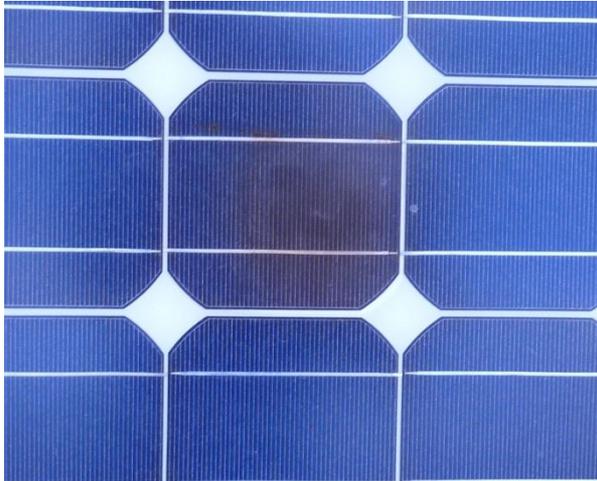
Hot spot/cell causing delamination of PVDF-based backsheet on module in Spain

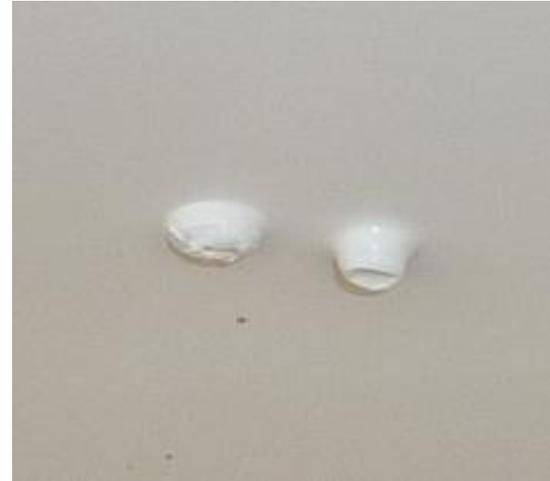
Additional examples of delamination on PVDF-based backsheet from hot spots in modules in Israel

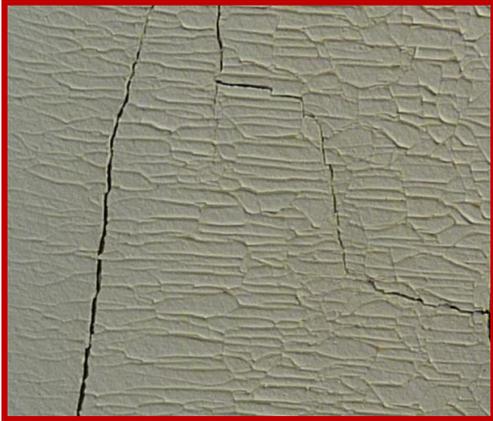
PVDF-based backsheet from module in Spain

- Module removed from service
- Cracking & yellowing

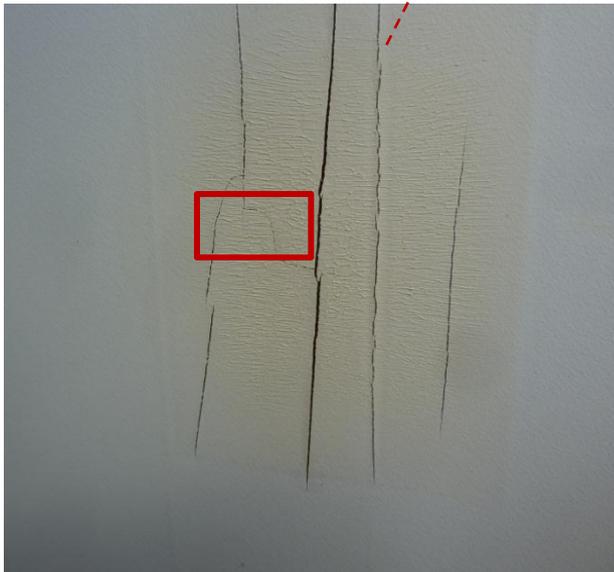
Polyester-Based Backsheet Cracking After 4 years

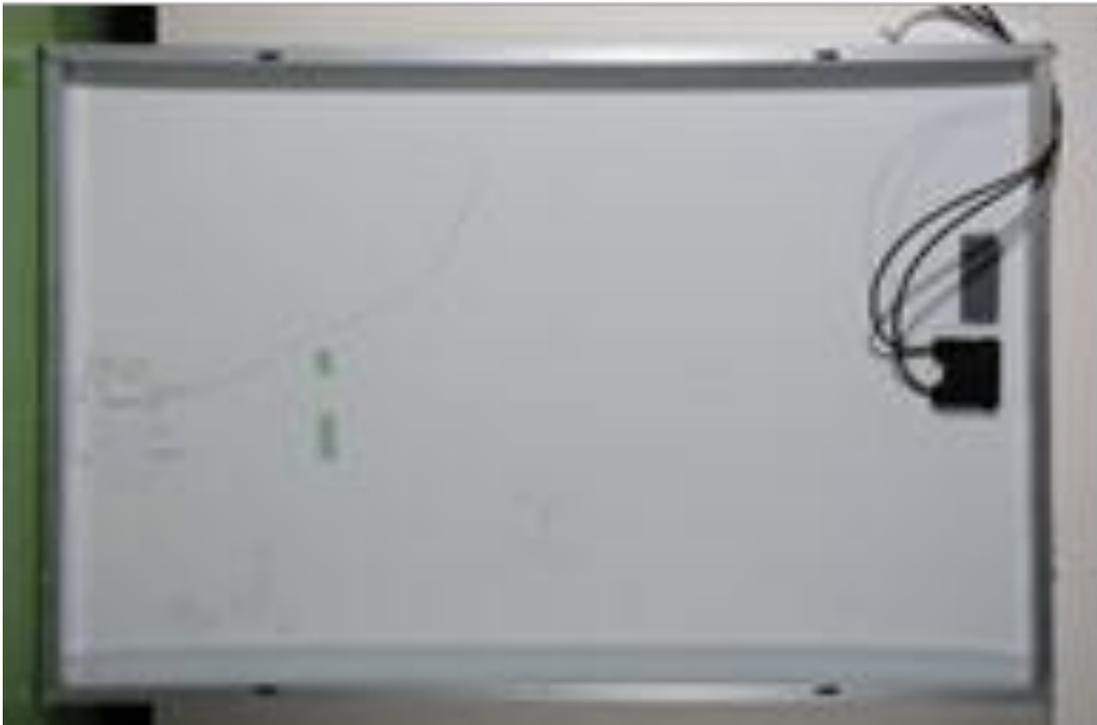
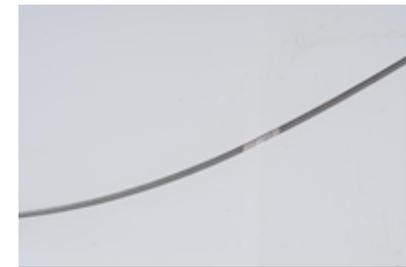
Crack in backsheet exposing tabbing ribbon and potential electrical leakage path

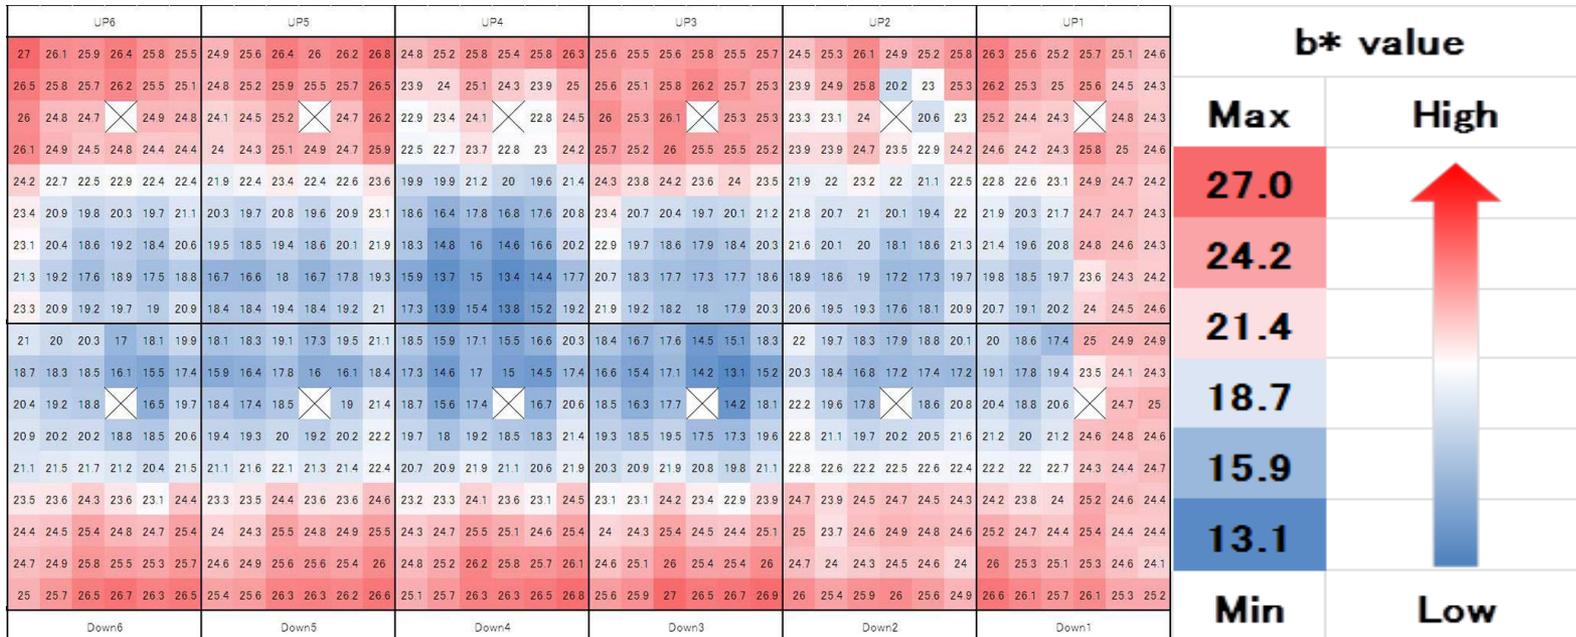
- PV array (12 modules) mounted on a metal corrugated rooftop of the commercial building for 15 years with ~150mm from corrugation to back of the solar panel
 - Outer PET layer cracking and brittle
 - High level of yellowing
 - Highest levels of yellowing near the edges of the array
- Other examples of PET-based backsheet yellowing, delamination and embrittlement have been previously described and examples from the field given

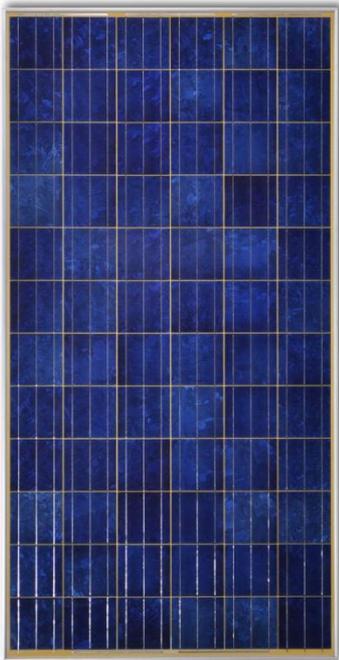
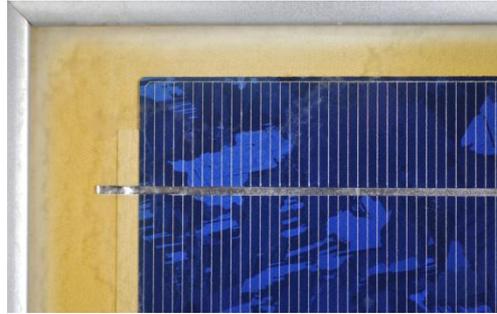
- Frontside yellowing observed in:
 - 5 different countries (Belgium, Spain, USA, Israel, and Germany)
 - Modules less than 5 years in the field
 - 5 different manufacturers

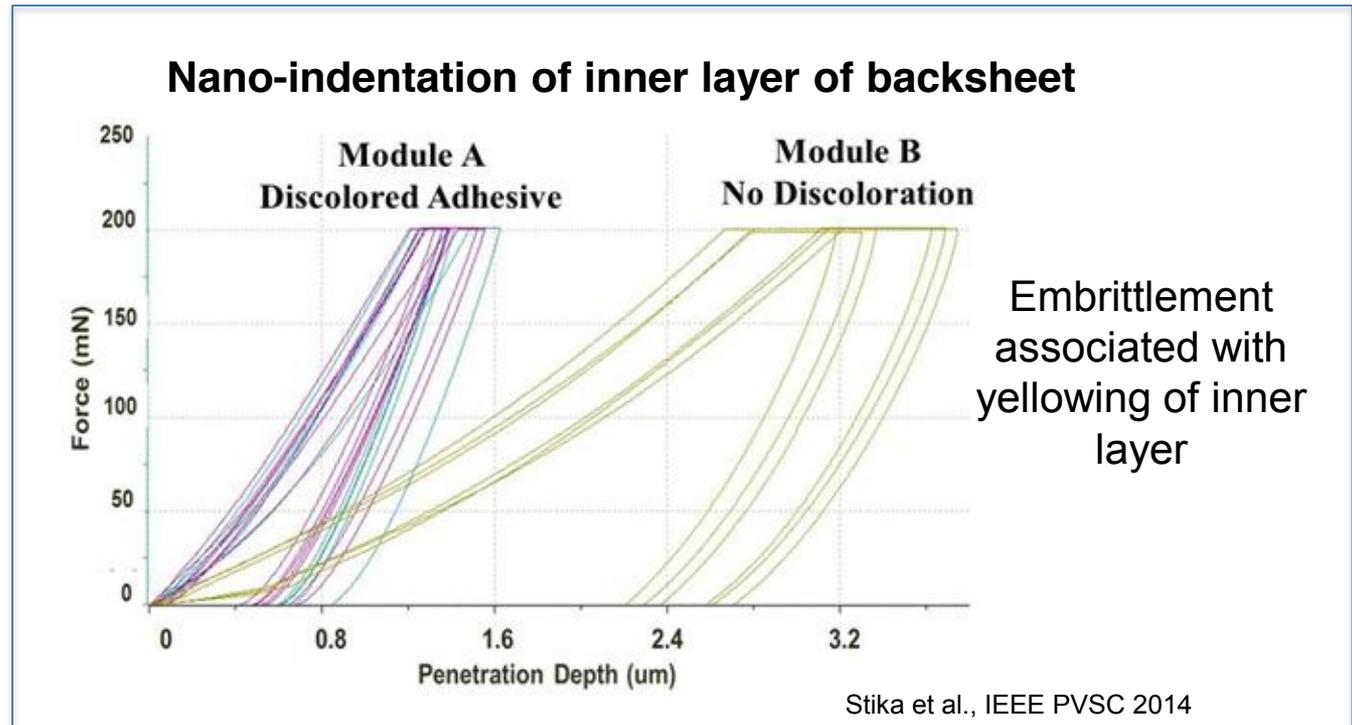
PET Inner Layer Discoloration

Area below cell has not discolored, indicating UV contributed to inner layer PET yellowing

4 years in field, 100% discoloration found in typical commercial/industrial systems (250-750 kW) both rooftop and ground mount, USA

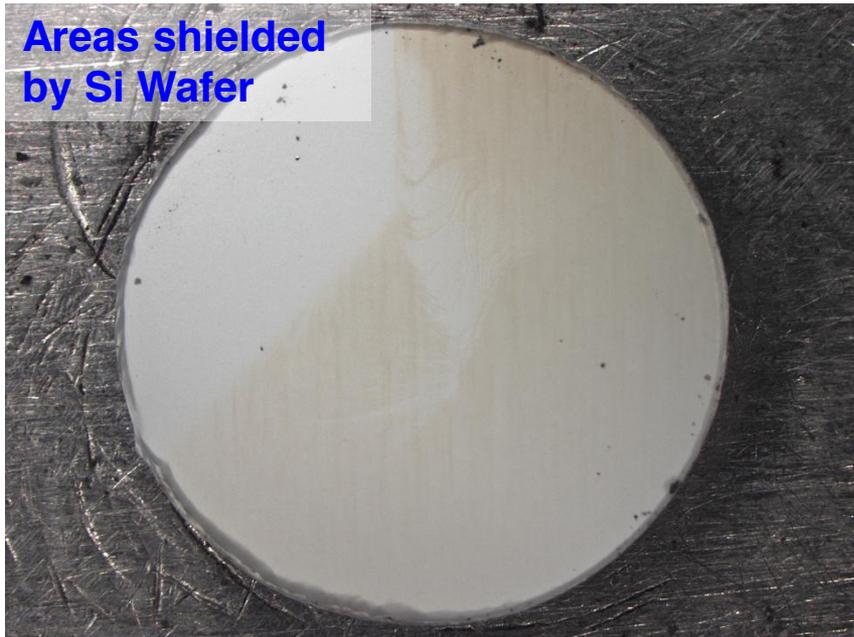
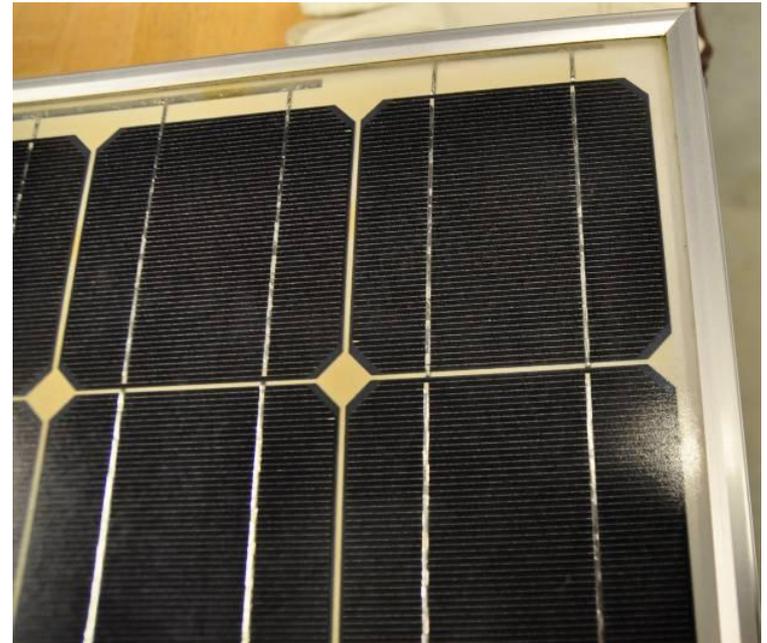
Rooftop Array, FEVE (5 years, Shanghai), >30% modules

Large amount of delamination

Bubbling and yellowing

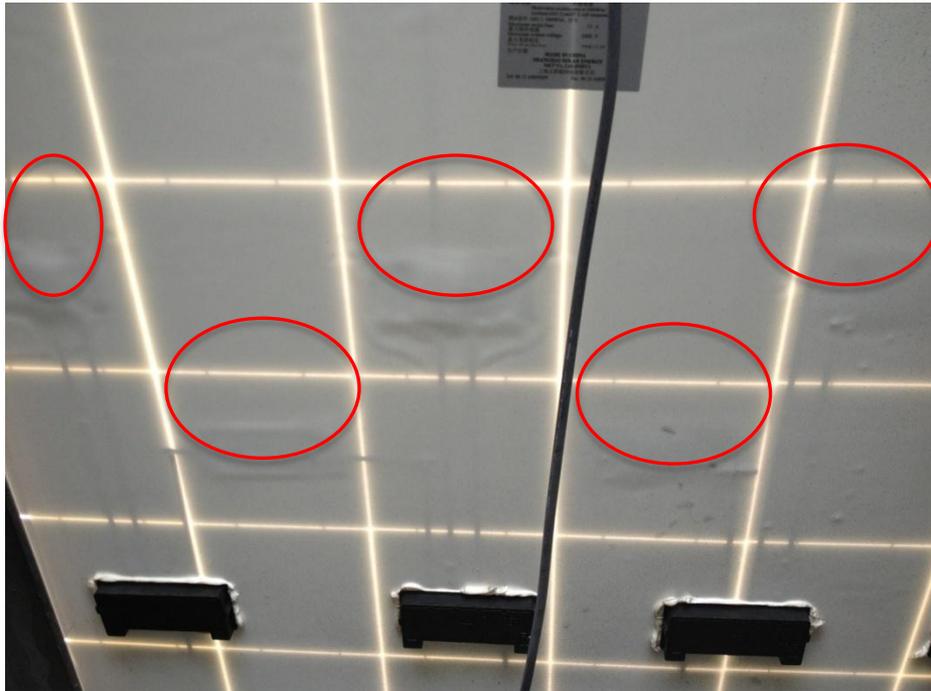
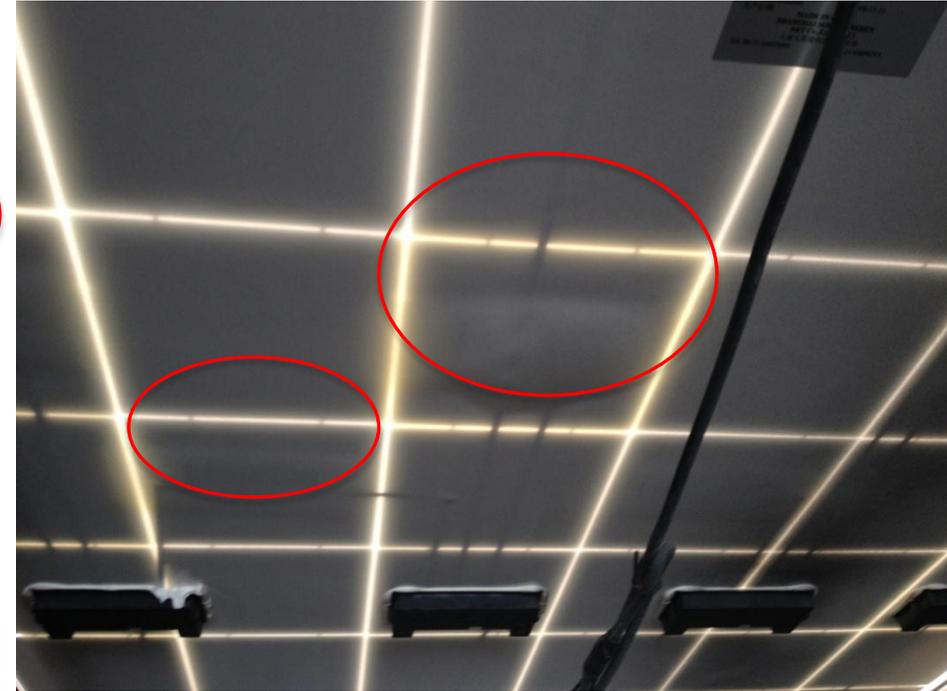
Control FEVE-based coated backsheet, no field exposure	FEVE backsheet samples with 5 years field exposure in Shanghai	Change
b* value (color)	0.04	2.57	2.53
60° Gloss change	70.2	44.9	25.3

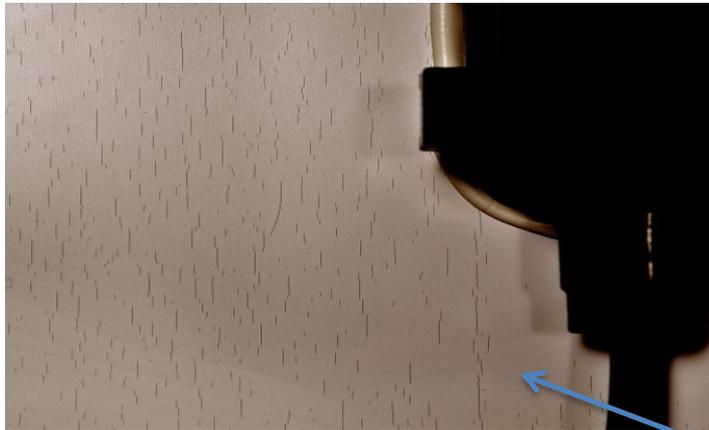
DH1000/UVA1000/TC200

Fine cracking of PVDF layer of 1s PVDF-based backsheet

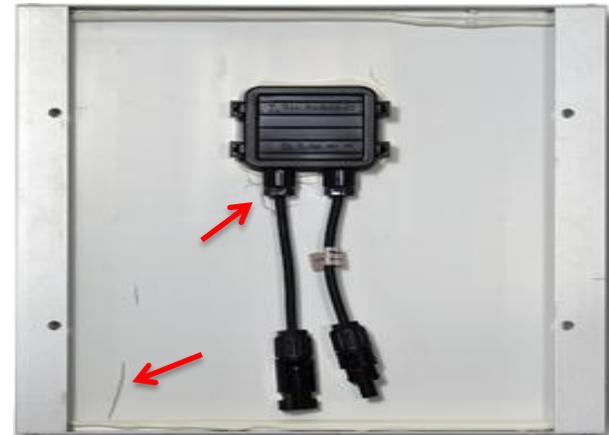
2x(DH1000/TC200)

Large cracks in 1s PVDF-based backsheet

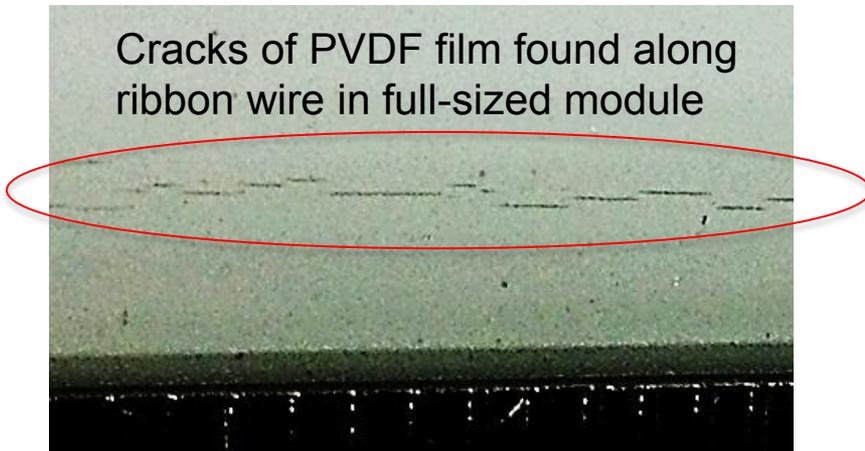
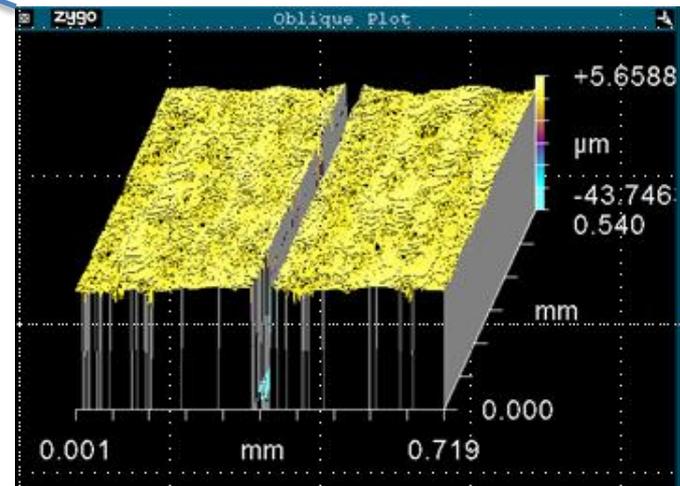
Cracks of PVDF film found along ribbon wire in full-sized module

* Cracks were along all back busbar ribbons on the module using 1s PVDF-based backsheet

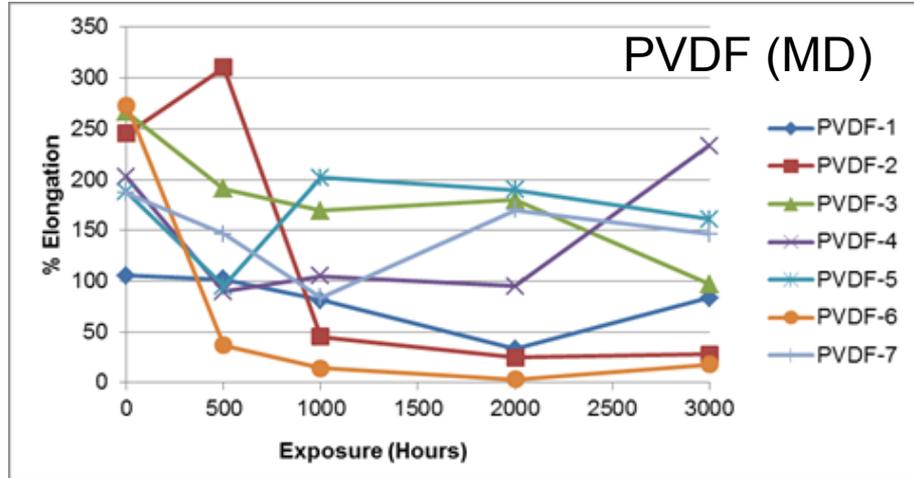
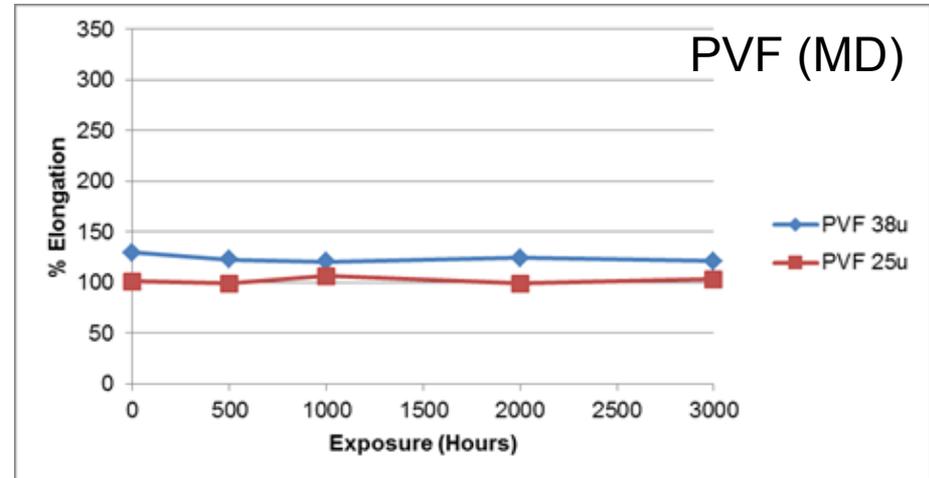
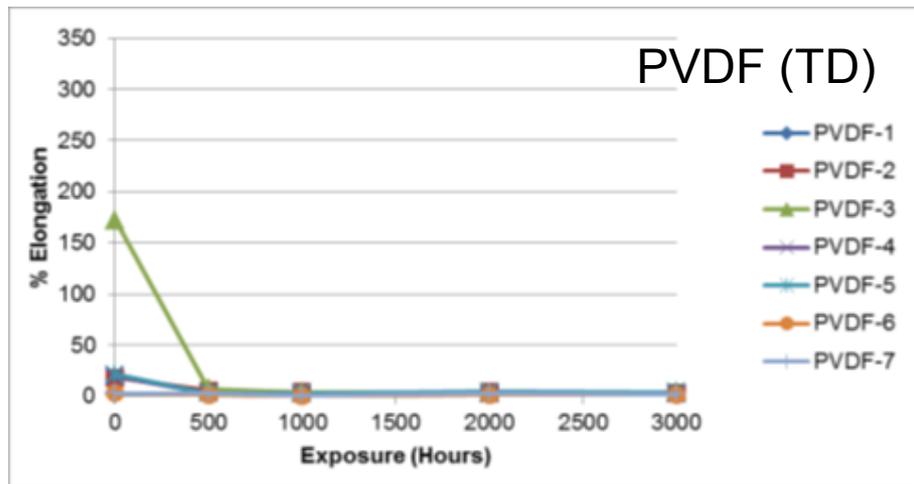
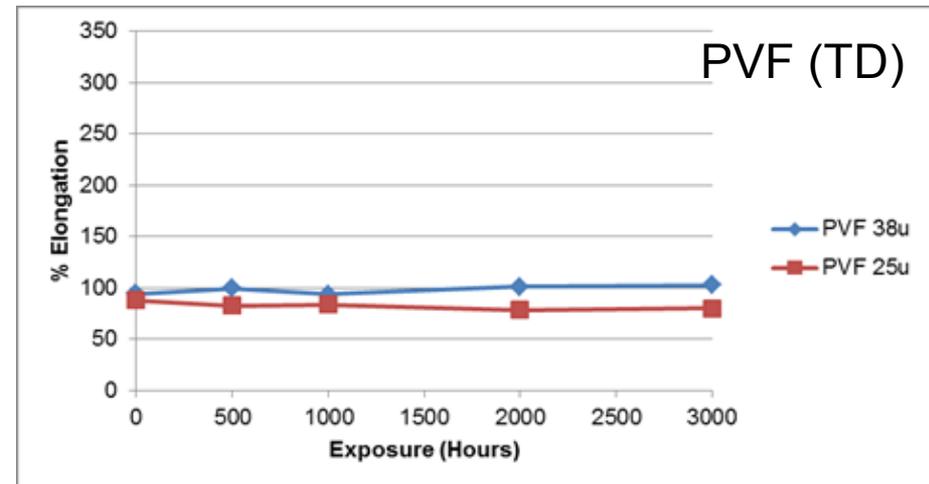
Mechanical Stress: PVDF Films Have Low TD Elongation and Get Brittle after Damp Heat Aging

Lower elongation may make PVDF film more vulnerable to cracking

Test Conditions: DH (85°C, 85%RH)

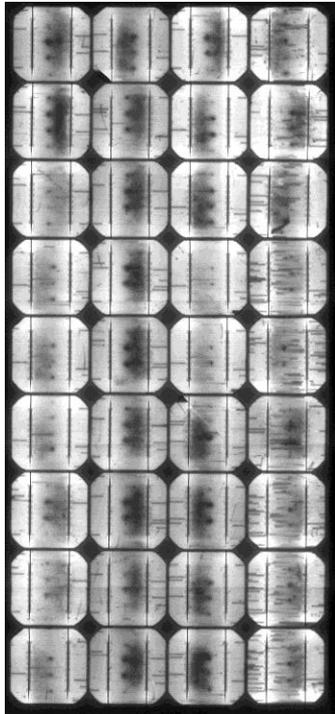
Field

- Age: 15 years, ΔP : -1.2%/yr

- Fine line degradation seen in fielded modules
- Similar to what is observed in loaded module weathering and sequential tests
- Not observed in extended damp heat

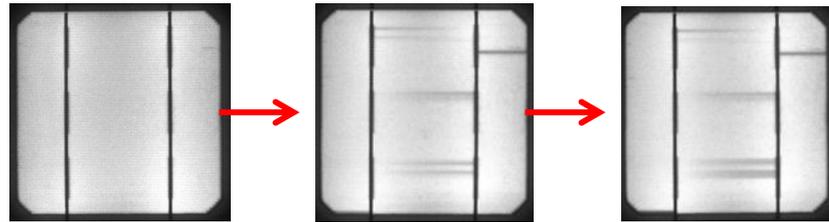
Load Module Weathering (DH500, WOM)

DH500 150 kWh/m² UV 180 kWh/m² UV

- 25y desert exposure
~2290 kWh/m² UV
