# Solar panel design factors to reduce the impact of cracked cells and the tendency for crack propagation

Andrew M. Gabor<sup>1</sup>, Rob Janoch<sup>1</sup>, Andrew Anselmo<sup>1</sup>, and Halden Field<sup>2</sup>

<sup>1</sup> BrightSpot Automation LLC, Westford, MA USA

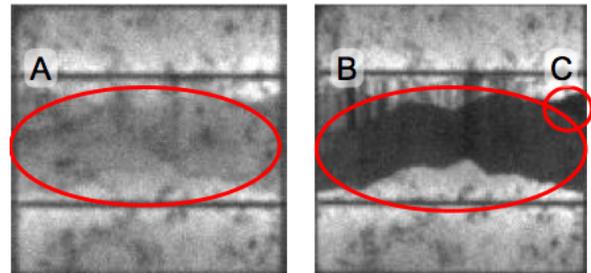
**Fig. 1:** Electroluminescence (EL) image of a cell with a crack a) before, and b) after humidity-freeze cycling. from ISFH<sup>3</sup>.

for modules with cracked cells as the continuity deteriorates and portions of the cells drop out of the circuit, as is shown in the Figure below from ISFH.<sup>3</sup>

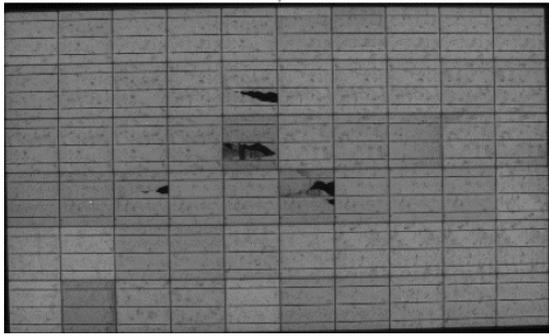
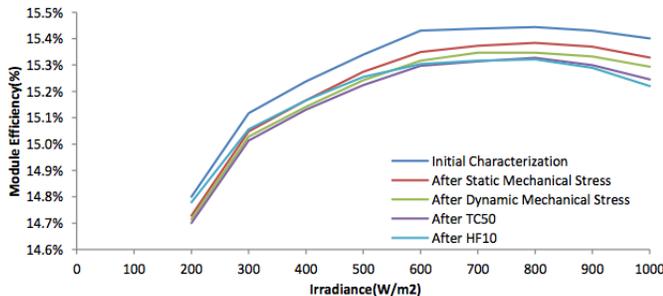
**Fig. 2:** . Electroluminescence image and efficiency vs. irradiance of a module after environmental testing - from Yingli.<sup>4</sup>

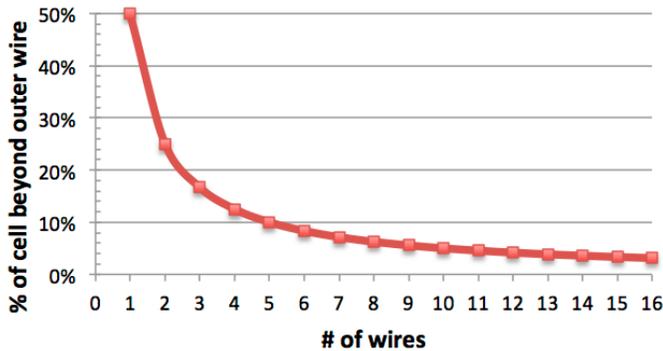
**Fig. 3:** Calculation of the worst-case scenario for cell area or current loss if an open crack occurs just outside one of the outermost wires as a function of the number of wires.

For a design with just 2 wires on a 156mm-wide cell,  $f$  is  $\sim 1/4$  of the cell width, and an open crack along this wire could result in a loss of  $\sim 25\%$  of the cell current. For 5 wires, the loss is only  $\sim 10\%$ , but the value of adding additional wires quickly diminishes regarding this concern.

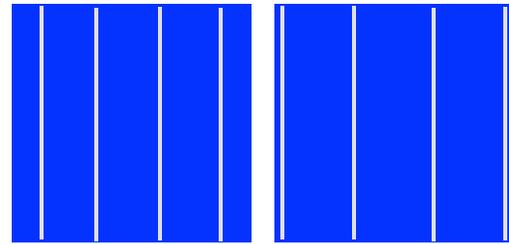
**Fig. 4:** 4-busbar cell with the conventional (left) and recommended (right) designs.

With the number of busbars now increasing within the industry beyond 3, we recommend placing the outer two busbars much closer to the cell edges (see Figure 4), since this will have a relatively small impact on resistive power losses in the fingers and could have a significant impact on module sensitivity to cracked cells. Should a crack occur outside the outer busbars, much less area will be lost.

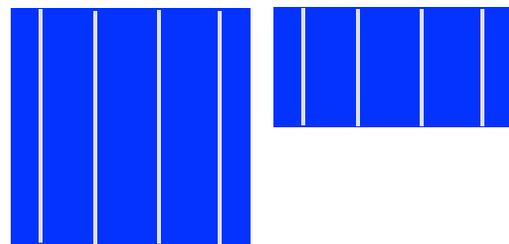
**Fig. 5:** Square cell and half-size cell designs.

The wire thickness is generally chosen to minimize resistive power losses which are proportional to the third power of the busbar length. A recent trend in module design is to use half-size cells so that the length of the wires is cut roughly in half. With the peak current along the wires cut in two, one can significantly reduce the wire thickness without incurring significant resistive power losses. These thinner wires cause less stress in the silicon, and thus reduce the density of microcracks and the chances for crack propagation. Rectangular cells have the additional benefits of enabling more light harvesting from light reflected off regions around the perimeter of the cells, and a slight reduction in NOCT values. They have the downside of an additional processing step to cut the cell, a potentially weak edge where the cut occurs, lower throughput of the soldering equipment, and a slightly larger module size due to the increased number of gaps between cells and an associated increase in the related materials costs such as encapsulant, glass, and backsheets.

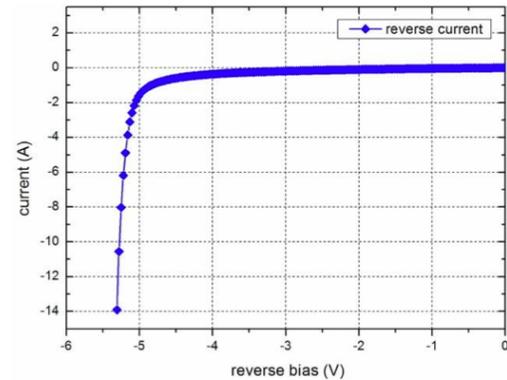
**Fig. 6:** Dark, reverse bias I-V curve of a Zebra IBC cell - from ISC-Konstanz<sup>10</sup>.

Reverse bias I-V characteristics vary widely among various wafer types, cell architectures, and even from cell to cell for a given technology. A variety of physical mechanisms are responsible for recombination that leads to increased currents in reverse bias.<sup>8</sup> A cell which enters “breakdown” mode at a relatively low reverse bias voltage would “fail” the common test at  $-12V$ , but actually may be superior in terms of module safety and performance. If the breakdown occurs at a low enough voltage, the product of current and voltage at the operating point may be low enough that only a fraction of the string’s power is dissipated across the cell, and if this power is dissipated in a uniform fashion across the area of the cell, no damage may be done to the module. Examples of cell architectures that can exhibit such reverse bias characteristics include variations of the IBC design where there is a long length of abutted p-n regions such as the classic Sunpower design,<sup>9</sup> and the Zebra<sup>10</sup> and Mercury<sup>11</sup> designs. Figure 6 shows an example of the reverse bias characteristics of the Zebra cell.

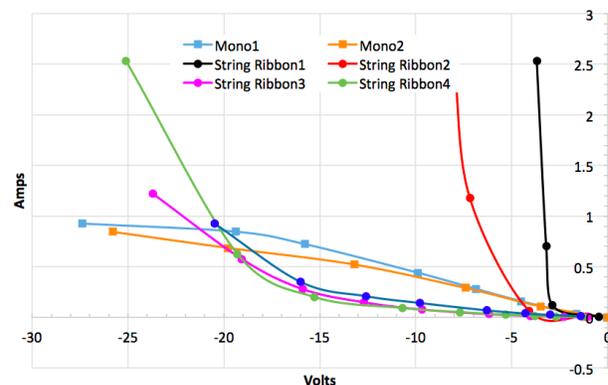
**Fig. 7:** Dark reverse bias characteristics of different cell types.

In testing some old Evergreen Solar String Ribbon cells, we found a wide range of reverse breakdown characteristics, some of which occurred at quite low voltage (see Figure 7). In this case, thermal camera images showed the heating under reverse bias to be non-uniform but over generally larger areas than was seen for monocrystalline cells. This raises the question of whether non-standard wafer types could be engineered to possess favorable reverse bias characteristics in a more consistent and uniform manner.

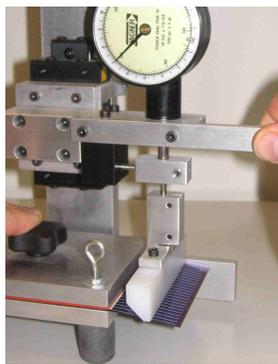
**Fig. 8:** Breakage strength tester utilized at Evergreen Solar for production quality control.<sup>1</sup>

While the emergence of electroluminescence (EL) testing has provided an incredibly valuable tool to aid in detecting open cracks following the stringing operation and during subsequent module processing, the reality is that cells can be heavily damaged by the soldering process, yet not develop visible cracks until after the module EL and IV testing. It is after the modules leave the factory and experience vibrations during shipment, and flexing during installation and snow/wind loads in the field that the majority of cracks will form. For this reason, the development of new measurement tools is needed to aid in process optimization and quality control. For example, in earlier work in soldering process and materials development at Evergreen Solar,<sup>1</sup> a breakage strength tester was used to quantify the soldering induced damage. Such a tester may provide complementary information beyond that given by more common wire pull strength tests.

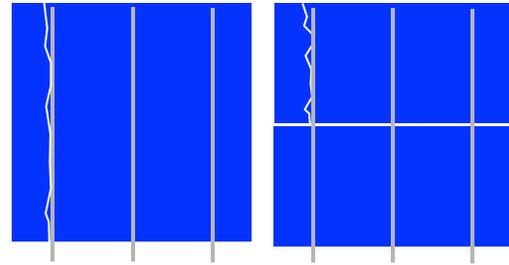
**Fig. 9:** A full cell with a crack, and two rectangular cells wired in parallel with one cracked cell.

If each cell in a module has a certain probability of developing a “problematic” crack, let us imagine that we divide each cell into two or more smaller cells that we wire in parallel. This can be accomplished by soldering wires from the top busbars of one cell to the top busbars of the adjacent cells in parallel before the wires extend to the backside of the next group of cells. In order to have the same lost area due to open cracks in the parallel-connected group, multiple problematic cracks would need to occur in the group. Since this is much less likely to occur than a single problematic crack in a full-size cell, the parallel-wired cell approach is much less likely to push cells into reverse bias power dissipation mode.

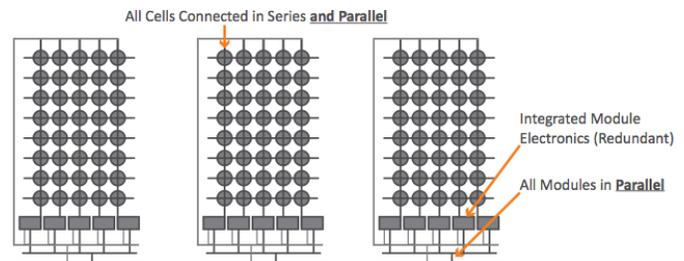
**Fig. 10:** Parallel cell wiring approach used by TenKsolar.<sup>13</sup>

An extreme example of such a design is the low-concentration architecture developed by Solaria where specially engineered glass focuses light on narrow slices of cells wired in parallel.<sup>12</sup> Parallel wiring of full-size cells has been adopted by TenKsolar to enable non-uniform illumination from its light harvesting system architecture as is shown below.<sup>13</sup>

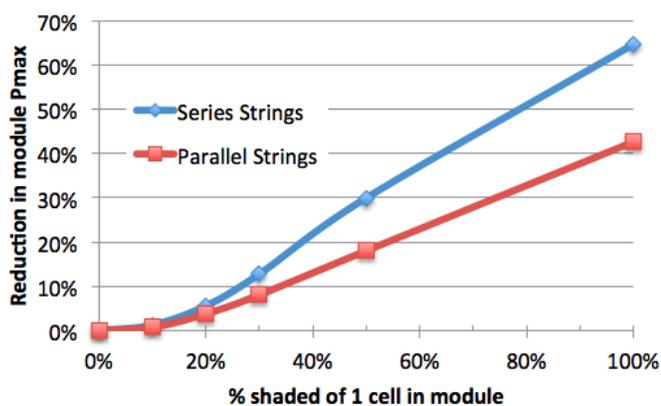
**Fig. 11:** Outdoor measured IV curves for a String Ribbon module at variable shading with strings in series and parallel wired modes.

To compare parallel vs series wiring we performed outdoor testing of an old Evergreen Solar panel (circa 1998) with 2 strings of 20 cells each. The panel allowed an easy change from series to parallel configuration of the strings with the change of jumper elements in the junction box. No bypass diodes were present in the junction box.

We performed IV measurements using a new, low-cost but high-accuracy, portable IV testing unit from PV Measurements. The module was measured outdoors under roughly 800 W/m<sup>2</sup> while one cell was shaded at varying levels in both

parallel and series configurations. Shading of the cell roughly simulates the condition of having open cracks that cause the same percentage of lost area. All current values were normalized to the change in current of a separate reference cell, although the reference cell varied little under the blue-sky conditions. As can be seen in Figure 11, the parallel configuration performs better under shading. These old-generation String Ribbon cells have FF's that are far worse than those of modern day cells, and we would expect the difference between series and parallel configurations to be even greater for modules using cells with high FF's.

The same robustness of the parallel-wired design to cell shading applies similarly to robustness for cracked cells with lost area. The potential disadvantages of the parallel wiring approach are 1) more complicated wiring within the modules, and 2) higher resistive power losses and/or thicker and more expensive wires at both the module and system levels.

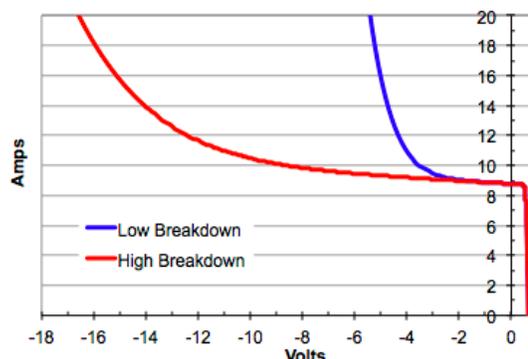
**Fig. 12:** Simulated IV curves for cells with high and low breakdown voltages that were used in the module simulations below.

We also examined the series/parallel vs cell shading/breakage issue by simulating module IV curves using the summation of individual cell IV curves with Microsoft Excel. We chose all cells to have identical IV curves except for the one shaded/broken cell. We used interpolation algorithms to enable the summing of IV curves at the same voltage values. A single diode model was used with an additional term to represent the reverse

bias term, similar to the approach followed by PI-Berlin.<sup>14</sup> We examined two cases for the reverse bias characteristics since the power dissipation in the shaded/broken cell depends strongly on these characteristics. Figure 12 shows the IV curves for illuminated cells with both a high “breakdown” voltage and a low breakdown voltage that matches the IBC cell characteristics.

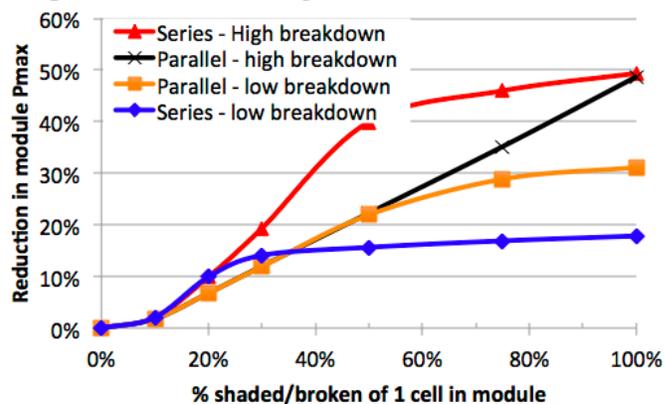
**Fig. 13:** Effect of broken-cell lost-area or shading of one cell in a 60-cell module with either all cells wired in series, or for 2 parallel strings.

Figure 13 shows the IV curves for a 60-cell module with no bypass diodes using 156mm cells where either all cells are connected in series or where two 30-cell strings are connected in parallel. The shading/lost-area of one cell in each module is varied from 0 to 100%. As can be seen, the low-breakdown condition helps tremendously when a large % of the cell is shaded or broken away. For more standard cells with high breakdown voltages, the parallel wired configuration is beneficial.
